War Memorials Trust Grants Scheme - Kirby Muxloe

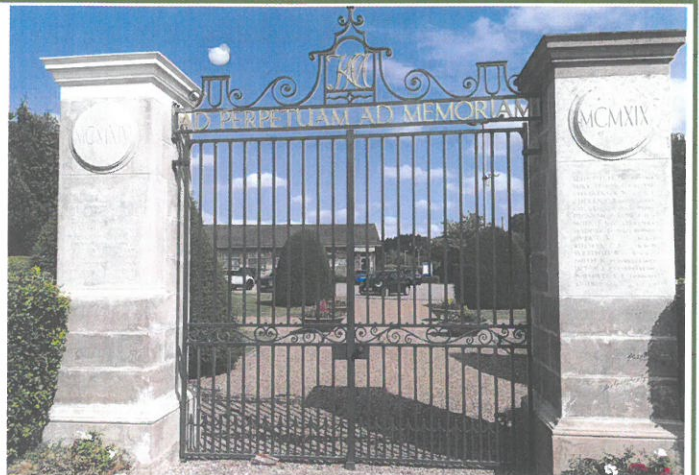
Above: Kirby Muxloe gates after works and below: pier before and after works (WM11506) © Kirby Muxloe Parish Council, 2021 and 2022

In 2021, conservation works were assisted with a grant of £3,280 from War Memorials Trust Grants Scheme supported by voluntary donations. The stone piers were steam cleaned. Construction joints were carefully raked-out and re-pointed using lime mortar. SmartWater was applied to all metal elements as part of the In Memoriam 2014 initiative to deter theft.

Repairs were also carried out to the stonework. Damaged areas were cut out and matching stone pieced in to reinstate the profile of the original design. The left pier cap was so badly damaged that it was replaced with new stone cut in a like-for-like style.

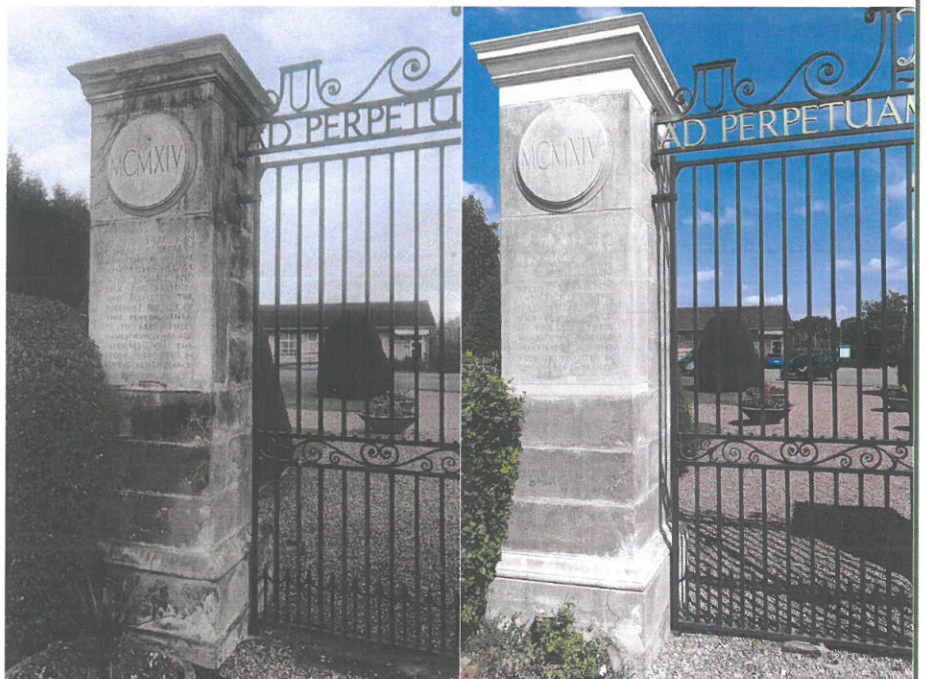
Following best conservation practice repair is always preferable to replacement. But in this case, the capstone was extremely friable so rain was causing it to crumble. As the cap is meant to keep water out, if the original was left, water would get inside. If the water then froze inside it would expand and cause the stone to crack.
